Nano Protect

Enhancing Engine performance and Emissions

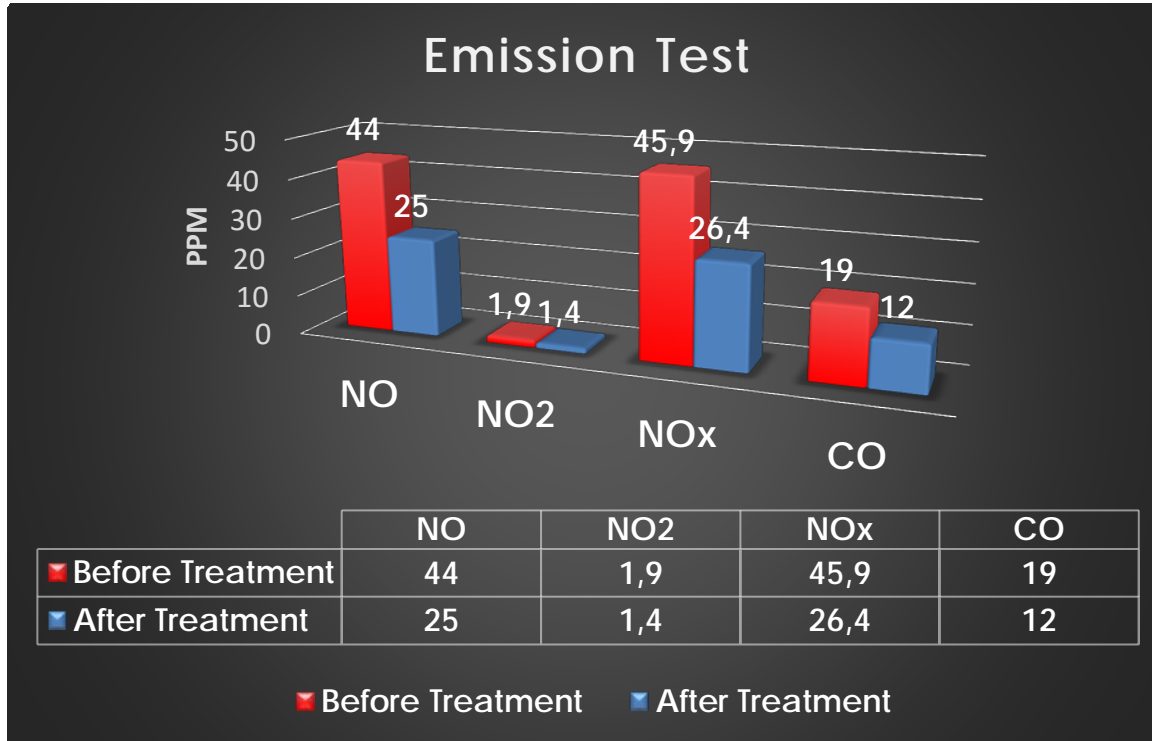
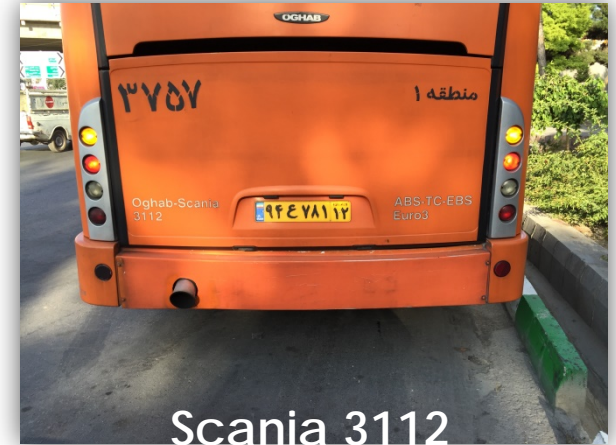
Test Bus 1 before and after measurement "NPS Engine Improvement treatment"

The first and second measurement was carried out with the engine running at 1200 rpm. Between the first and second measurement the bus has driven for 348,3 km.

<u>NO</u>	<u>NO2</u>	<u>NOx</u>	<u>CO</u>
Average reduction %	43,2 %	26,3 %	42,5 %	36,9 %
Fuel reduction %	Measurement performed after driving 2000km A saving of 9,6%

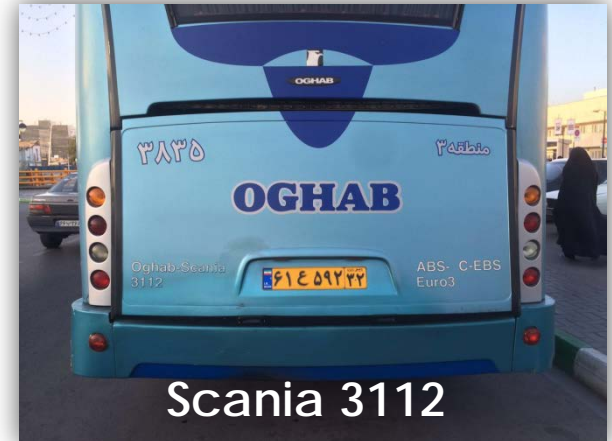
Test Bus 2 before and after measurement "NPS Engine Improvement treatment"

The first and second measurement was carried out with the engine running at 1200 rpm. Between the first and second measurement the bus has driven for 298 km.

<u>NO</u>	<u>NO2</u>	<u>NOx</u>	<u>CO</u>
Average reduction %	95 %	15,8 %	94 %	62,9 %
Fuel reduction %	Measurement performed after driving 2000km <u>A saving of 9,4%</u>

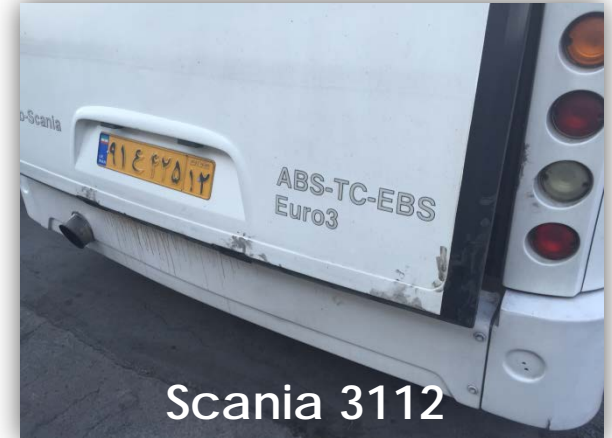
Test Bus 3 before and after measurement "NPS Engine Improvement treatment"

The first and second measurement was carried out with the engine running at 1200 rpm. Between the first and second measurement the bus has driven for 343 km.

<u>NO</u>	<u>NO2</u>	<u>NOx</u>	<u>CO</u>
Average reduction %	70 %	23,1 %	62,3 %	37,5 %
Fuel reduction %	Measurement performed after driving 2000km <u>A saving of 9,6%</u>

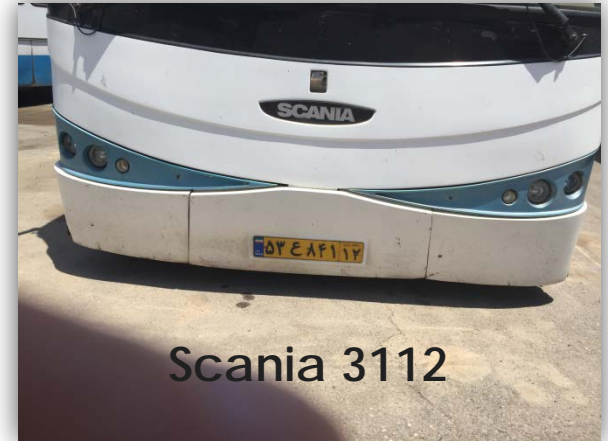
Test Bus 4 before and after measurement "NPS Engine Improvement treatment"

NO	NO2	NOx	CO
Before Treatment	20	4,7	32,7	19
After Treatment	14	2,2	16,2	6

The first and second measurement was carried out with the engine running at 1200 rpm. Between the first and second measurement the bus has driven for 328 km.

<u>NO</u>	<u>NO2</u>	<u>NOx</u>	<u>CO</u>
Average reduction %	30 %	53,2 %	50,5 %	68,4 %
Fuel reduction %	Measurement performed after driving 2000km A saving of 9,4%
